Manhole Inspection Summary

Manhole # S37M__014MH

Insp Date: **8/28/08 10:49 AM**

Location Address: **rusty scupper**

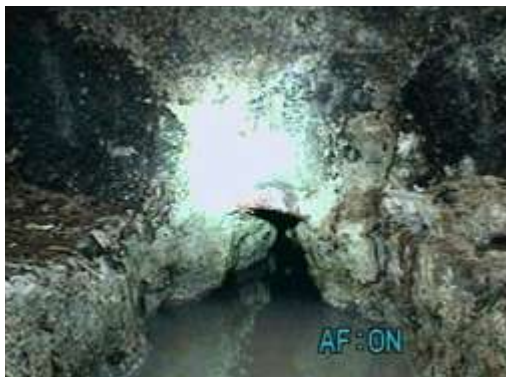
Defect 2

Condition: ☐ Sound ☐ Cracked ☐ Root Intrusion ☐ Deteriorated ☐ Leaks ☒ **Debris**

channel debris

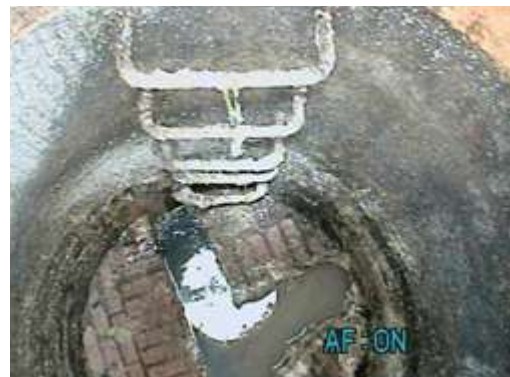
Defect 1

Count: **5** Missing: **0** ☒ **Corroded**

steps

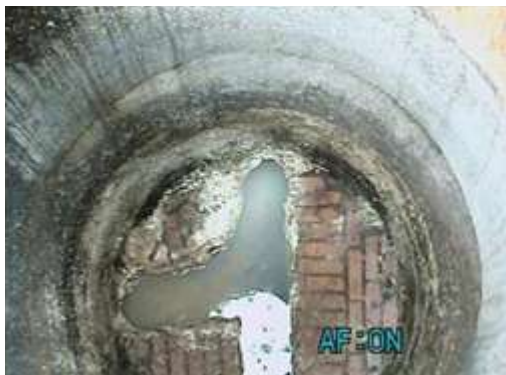
Defect 3

Infiltration: ☐ None ☒ **Joint** ☐ Cracks ☐ Mortar ☐ Roots ☐ Wall

Infiltration from corbel joint

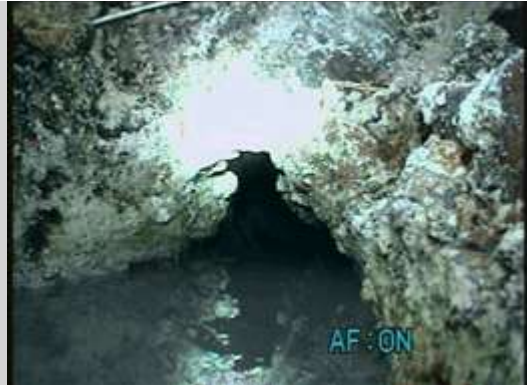
12 O'Clock Outflow

Pipe Height: **0** (in.) Direct
Pipe Material: **Clay** ☐ Pipe Lined
Invert Depth: **7.92** (ft.) Flow Characteristics: **Slow**
Deposits: ☐ None ☐ Mud ☐ Sludge ☒ **Debris** ☐ Grease
Silt Depth: **3** (in.) Deposits Extent: **Light**
Infiltration: **None** Pipe Seal Cond: **Unknown**

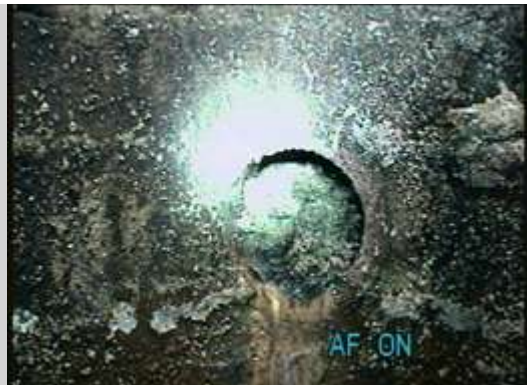
6 O'Clock Inflow

Pipe Height: **0** (in.) Direct
Pipe Material: **Clay** ☐ Pipe Lined
Invert Depth: **7.83** (ft.) Flow Characteristics: **Slow**
Deposits: ☐ None ☐ Mud ☐ Sludge ☒ **Debris** ☐ Grease
Silt Depth: **7** (in.) Deposits Extent: **Heavy**
Infiltration: **None** Pipe Seal Cond: **Unknown**

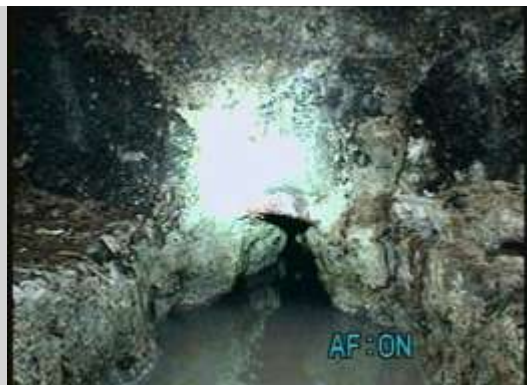
9 O'Clock Inflow

Deposits: ☐ None ☐ Mud ☐ Sludge ☐ Debris ☒ **Grease**

Silt Depth: **6** (in.) Deposits Extent: **Heavy**
